COASTAL CONSTRUCTION CONTROL LINE
REVIEW AND REESTABLISHMENT STUDY
FOR BAY COUNTY

Bureau of Beaches and Coastal Systems
Division of Environmental Resource Permitting

Beaches and Shores Resource Center
Institute of Science and Public Affairs
Florida State University
Tallahassee, Florida 32306

July 1996

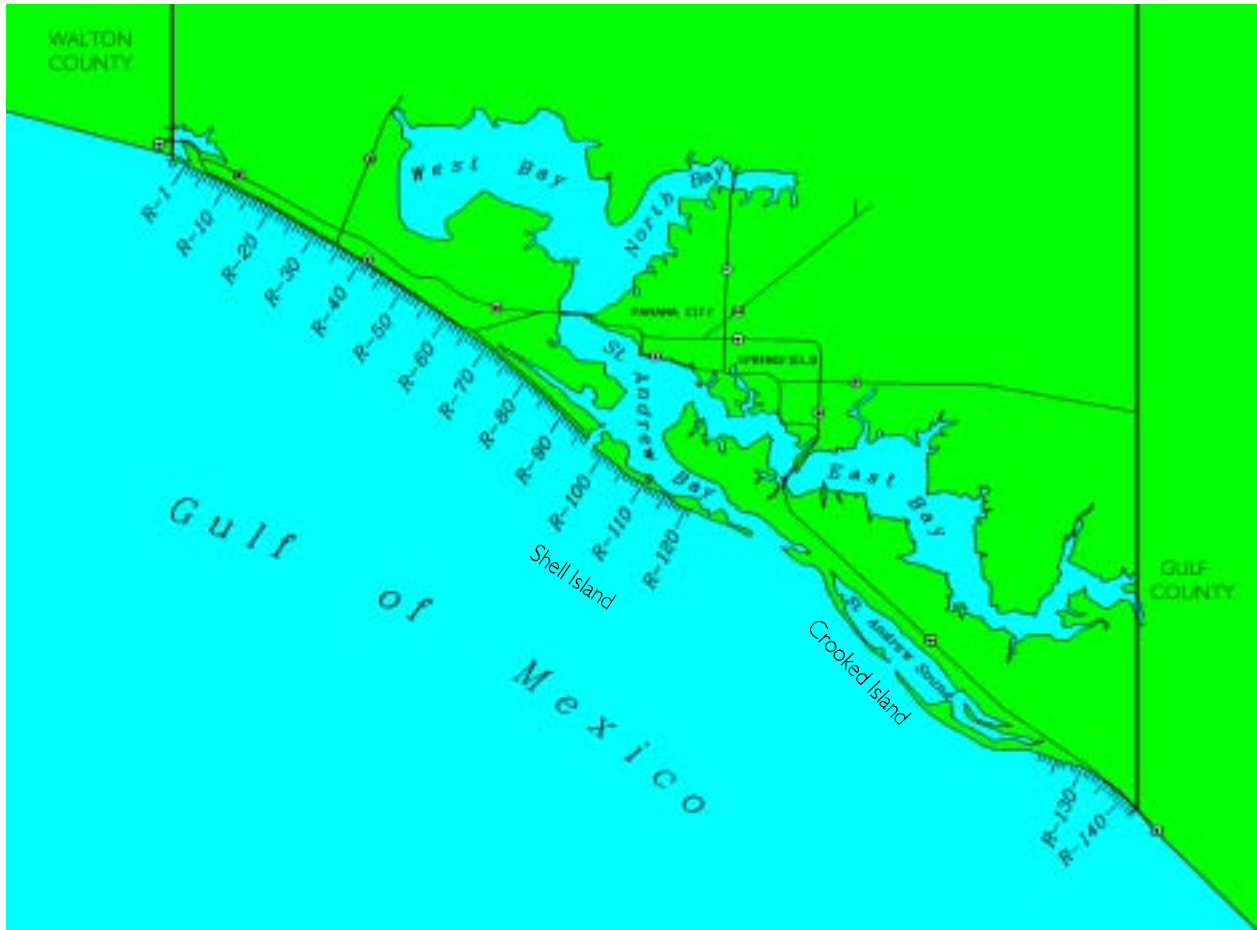
Figure 2 Location Map of Study Area and Range Lines for Bay County

A monumented baseline was placed along the 33 mile shoreline of Bay County coastal area, from the western county line to the eastern county line, except the 11 mile segments of federal land. Monumented stations approximately 1,000 ft. apart were placed on the baseline in 1970 and have, since then, been maintained (see Figure 2). Beach profiles from the top of the dune (where existing) to a wading depth were surveyed in December 1972-October 1973, February-March 1992 and in March-May 1995. Offshore soundings at every third monument from the beach to a depth over 30 ft. were made with the surveys of 1971. Offshore soundings to a point about 3,000 to 6,000 ft. offshore (about 20 to 60 ft. in depth) were made at every monument on the baseline for the control line surveys of 1995. Figure 2 shows the location of the beach profiles (R-1, R-2, etc.) and some typical beach profiles surveyed in 1995 are shown in Appendix A. Exhibit B presents the complete set of beach profiles surveyed in March-May 1995. Visual information and photographic ground coverage were also carried out during each survey period and on special occasions.

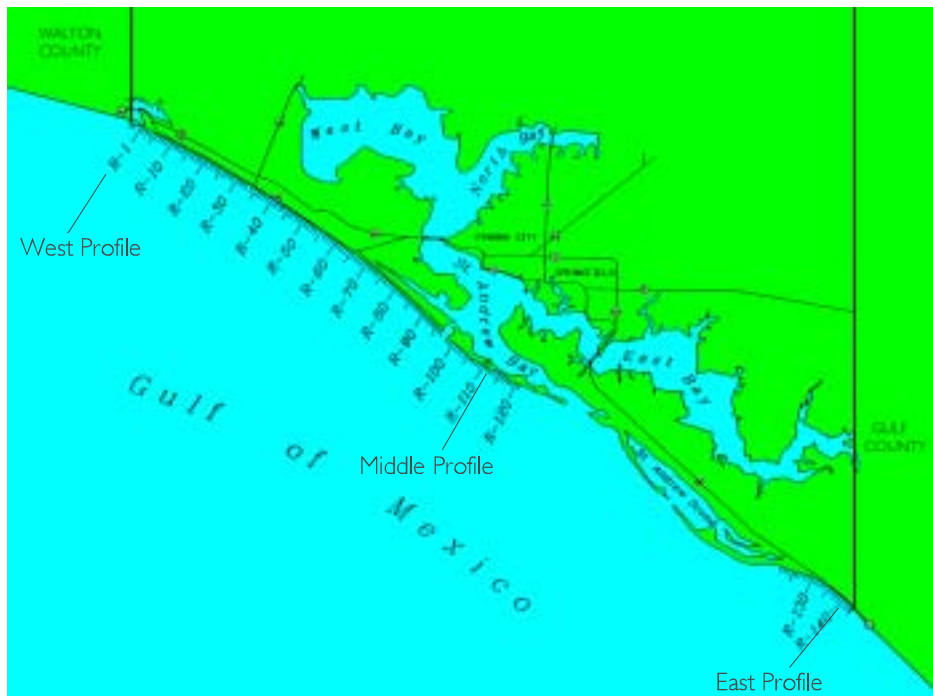
Figure 4 Location Storm Tide Simulation Profiles

Storm surge is the vertical rise in the still water level near the coast caused by reduction of atmospheric pressure and wind stresses on the water surface. Wave setup is the superelevation of the water surface above storm surge level due to onshore mass transport of the water by wave action alone. There exist only a very limited number of reliable records of water levels on the open coast during major hurricanes which have occurred in the past. In the study of storm tides in Florida (9), the Coastal and Oceanographic Engineering Department of the University of Florida has analyzed the normal yearly high tides and high water levels caused by storms/hurricanes and expressed the results as frequency of occurrence for a certain water level to be equaled or exceeded. In that study, all available normal yearly high tide and storm surge data along the coast of Florida before 1959 were analyzed and correlated to provide the tidal level-frequency information for the open coast of Florida. The National Oceanic and Atmospheric Administration (NOAA) and the Federal Emergency Management Agency (FEMA) has done numerical modeling of storm surge in Bay County. For the present study, refined joint probability numerical modeling of hurricanes has been carried out to obtain sufficient details of the storm tide frequency in Bay County. In the joint probability numerical modeling, the hurricane parameters, astronomical tide, dynamic wave setup and Coriolis force are all taken into consideration to obtain the combined total storm tide frequencies. Two separate reports (10, 11) present all the details in the analysis. Figure 3 shows the combined total storm tide frequencies resulting from the numerical analysis (11) at three locations along the Bay County shoreline. The sites of the three locations, i.e., west profile, middle profile, and east profile are depicted in Figure 4.

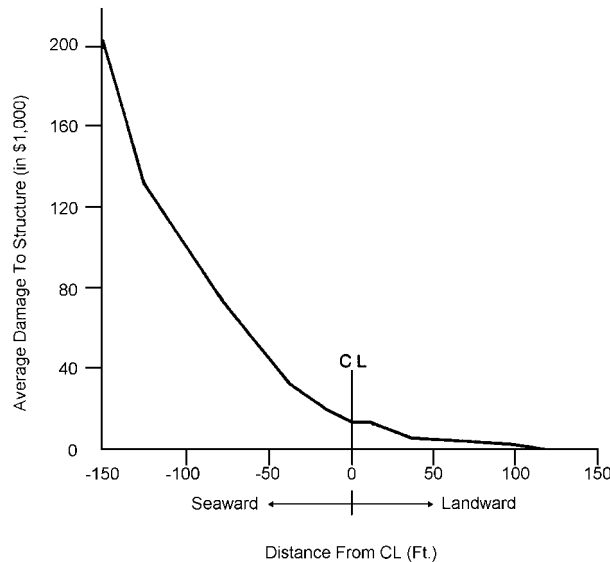
Figure 5 Damage to Structure in Relation to its location with Control Line (resulting from study of 540 structures in Bay County after Hurricane Eloise, By Shows, 1976)

Coastal development has been substantial in the Panama City Beach area westward to near Phillips Inlet. Impactive and imprudent development has destroyed most of the barrier dune system of western Bay County and rendered the area vulnerable to storm surge flooding, erosion and wave damage (16). Hurricanes of 1975 (Eloise), 1985 (Kate) and 1995 (Opal) have all caused erosion and destruction to the county's coastal area. It is, therefore, obvious that coastal development in Bay County carries a high "risk factor". So, it cannot be emphasized too strongly that future development should be carefully planned and engineered to minimize the risks as much as possible. Figure 5 shows the structure damage (at 1975 dollar value) versus structure location in relation to the control line in Bay County. The data are taken from a study made by Shows (17) after Hurricane Eloise of 1975. The figure shows clearly that damage per structure increases sharply seaward from the control line, levels off at the CL, and reduces gradually landward.

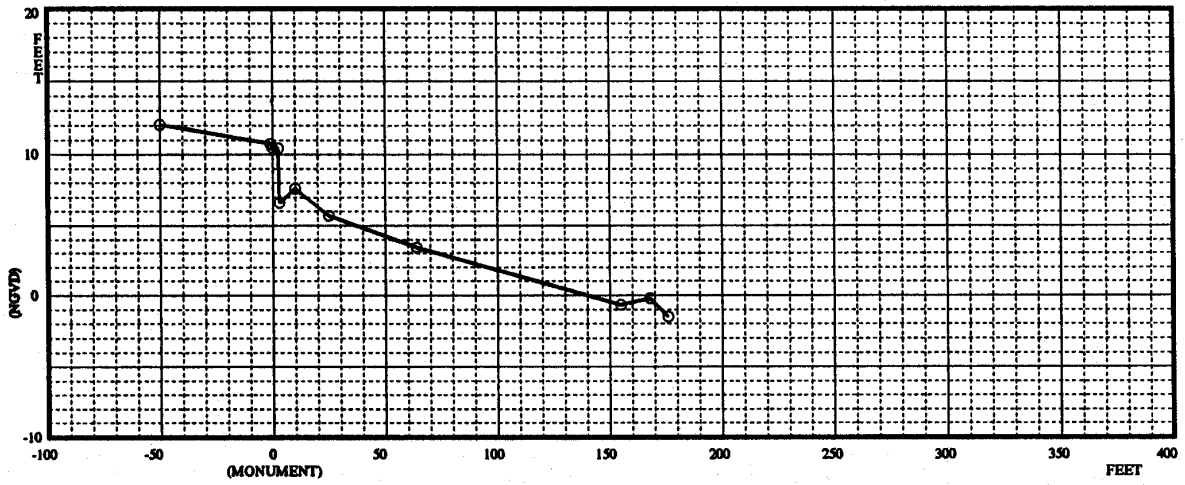
Figure A4 Beach Profile at Range No. 59 (R-59)

BEACH PROFILE
 ○—○—○ 03 MAR 95

Range: **R059**
 MONUMENT ESTABLISHED: JAN 1971
 BEARING S 32 00' W (MAG.)
